Zoll XA Series Quick Reference Troubleshooting Guide

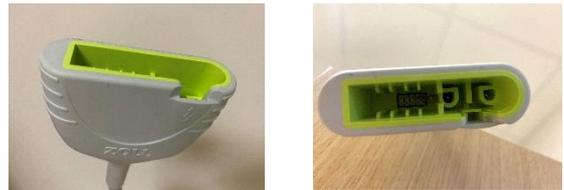
Defib/Therapy cables.

The Zoll XA is equipped with a multi-function connector (MFC) on the defibrillation cable. There are a number of reports of damage to the data pins inside the MFC. This may be caused by inadvertent placement of the 30 joules test connector. Exercise caution when connecting the 30j connectors as, alongside the possibility of damage to the data pins, the bent pins may prevent the defibrillator pads being able to make firm contact with the power connections inside the MFC.

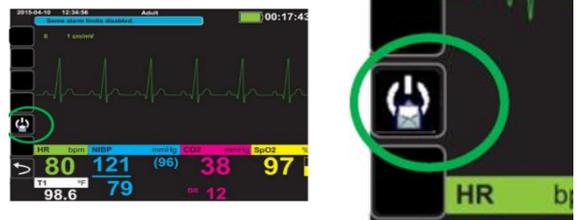
Auto case push. [\(Click NASC-Zoll 2024-4\)](#)

It is extremely important that all data is captured for each patient contact where the Zoll X-A has been used. The auto case push function has been demonstrated during initial training and is the only way the device should be power off on all occasions. Failure to transmit the most recent cases(s) on shut down, may be a local cellular signal issue, especially if 2 way transmission to the server was confirmed during the pre-shift check.

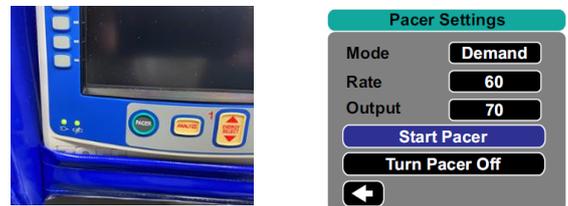
Pacer mode. [\(Click NASC-Zoll 2024-5\)](#)

While pacing is not currently an authorised intervention at any clinical level, it is possible that the function may be inadvertently switched on. Defibrillation is not possible in this scenario. If this should happen; in the Pacer setting pop up menu, use the navigation keys to place the blue cursor over the “turn off pacer” and select. You will need to manually change back to “Pads” view from lead II.

As an alternative method of exiting Pacer mode, press the “Charge” button which will bring the device in the defibrillator mode and exit pacing.
